**TOWN OF RAYMOND
BYLAW NO. 1077-19**

A BYLAW OF THE TOWN OF RAYMOND TO DESIGNATE THE SITE KNOWN AS THE
TOWN HALL, AT 10 BROADWAY NORTH, RAYMOND AS A MUNICIPAL HISTORIC
RESOURCE

TOWN HALL

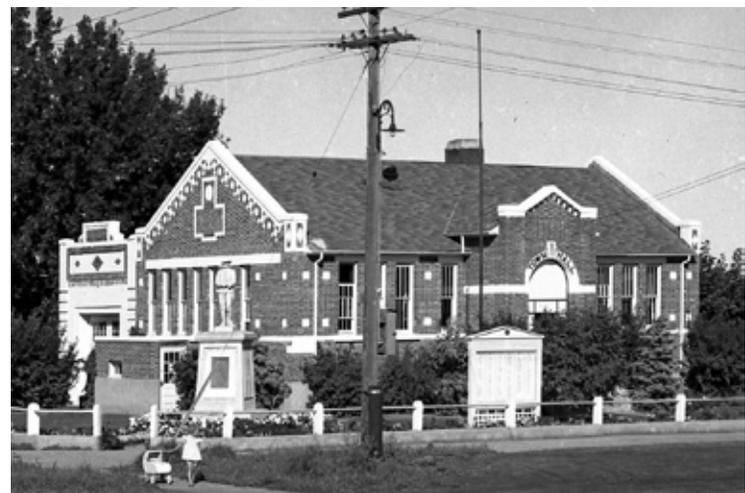
Raymond's Town Hall as it appeared in the 1930s. Note the entrance to the fire hall on the south elevation (left).
Raymond & District Historical Society AP2011-010-001
